General Home Inspection

123 Any Street
Your New City, Ohio 12345

Prepared for: John and Jane Homebuyer

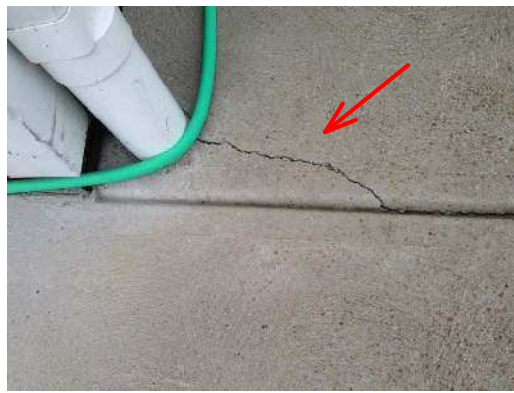
Acceptable Driveway: Concrete
Needs Maintenance Walks: Concrete - Crack in concrete, recommend filling to avoid further damage

1. Walks: Concrete - Crack in concrete, recommend filling to avoid further damage

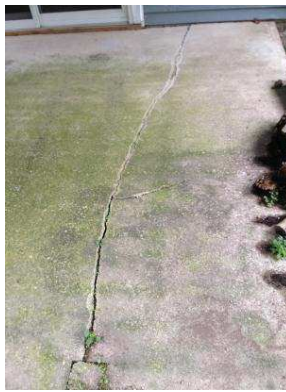
Acceptable Steps/Stoops: Concrete
Acceptable Porch: Concrete
Needs Repair Patio: Concrete - Crack in concrete, recommend filling to avoid further damage, Heavily cracked and unevenly settled causing trip hazard

1. Patio: Concrete - Crack in concrete, recommend filling to avoid further damage, Heavily cracked and unevenly settled causing trip hazard

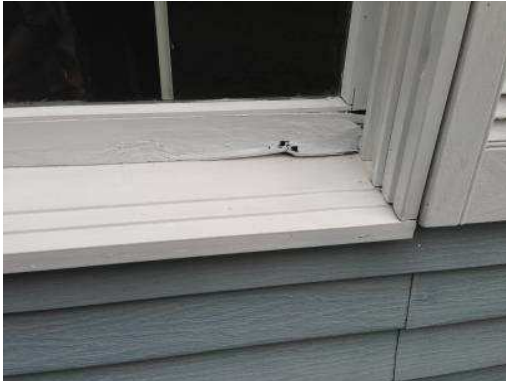
Windows: Wood double hung - **Rotted wood on exterior window sash**

2. Windows: Wood double hung - Rotted wood on exterior window sash
3. Exterior Electric Outlets: 110 VAC - Non-GFCI outlet, Exposed wiring present, Inoperative at time of inspection, Recommend installing a GFCI outlet in all exterior outlets
4. Hose Bibs: Gate - Signs of past or present leakage, A licensed plumber is recommended to evaluate and estimate repairs

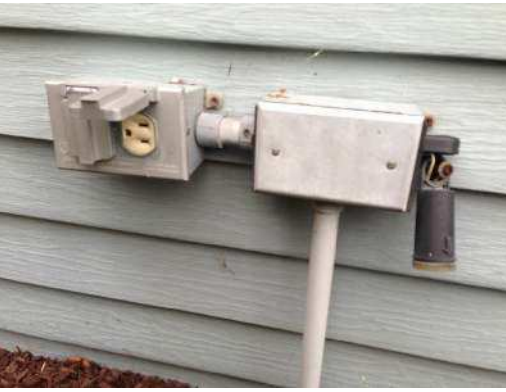
Window Screens: Vinyl mesh
Basement Windows: Wood casement
Exterior Lighting: Surface mount
Exterior Electric Outlets: 110 VAC - **Non-GFCI outlet, Exposed wiring present, Inoperative at time of inspection, Recommend installing a GFCI outlet in all exterior outlets**

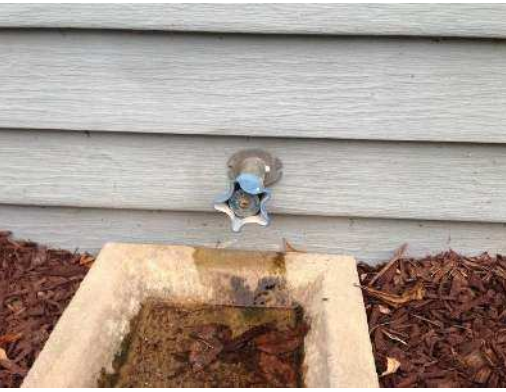
Hose Bibs: Gate - **Signs of past or present leakage, A licensed plumber is recommended to evaluate and estimate repairs**

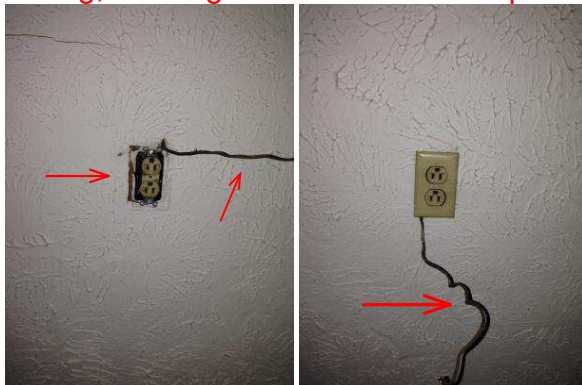
Acceptable	Garage Doors: Insulated aluminum
Acceptable	Door Operation: Mechanized
Acceptable	Door Opener: Genie
Acceptable	Exterior Surface: Vinyl siding
Acceptable	Roof: Asphalt shingle
Acceptable	Roof Structure: 2x4 Truss
Acceptable	Ceiling: Texture paint
Acceptable	Walls: Drywall
Acceptable	Floor/Foundation: Poured concrete
Acceptable	Hose Bibs: Rotary
Needs Repair	Electrical: 110 VAC - Protect exposed surface mounted wiring running along garage ceiling, Missing outlet/switch cover plates

5. Attached Garage Electrical: 110 VAC - Protect exposed surface mounted wiring running along garage ceiling, Missing outlet/switch cover plates

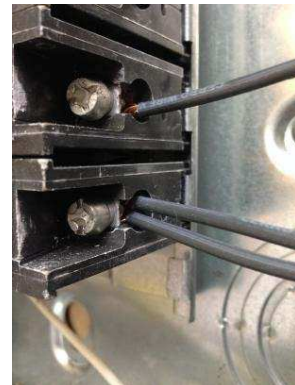
Basement Electric Panel
 Acceptable Manufacturer: General Electric
 Maximum Capacity: 100 Amps
 Acceptable Main Breaker Size: 100 Amps
 Needs Repair Breakers: Copper - **Double taps are present at breakers. These circuits need to be moved to their own circuit breaker and cannot share a breaker. It is recommended that a qualified electrician inspect the new circuits and properly connect the new circuits to an individual breaker for each circuit**

6. Ground: No ground present in panel - Grounds should be located from panel to ground rod outside of home and to the water main, where they should be affixed to the home side and service side, from the street.
7. Basement Electric Panel Breakers: Copper - Double taps are present at breakers. These circuits need to be moved to their own circuit breaker and cannot share a breaker. It is recommended that a qualified electrician inspect the new circuits and properly connect the new circuits to an individual breaker for each circuit
8. Basement Electric Panel Sub Panel: Sub panel has open "knock-out" hole- insert "blank-out" cap to close off opening

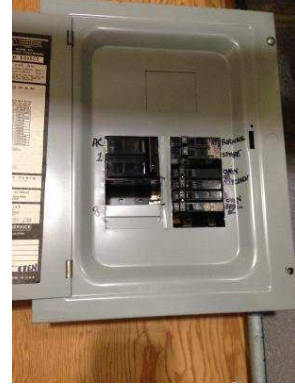
Acceptable GFCI: Kitchen and bathrooms
 Is the panel bonded? Yes
 Needs Repair Sub Panel: Sub panel has open "knock-out" hole- insert "blank-out" cap to close off opening

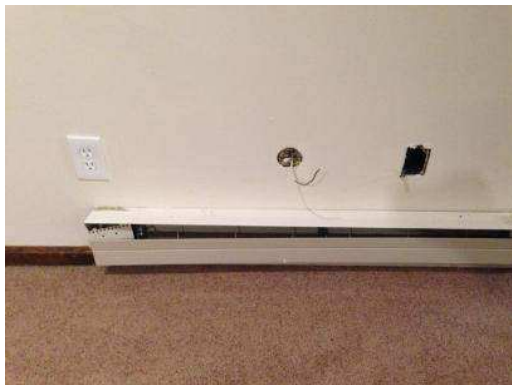
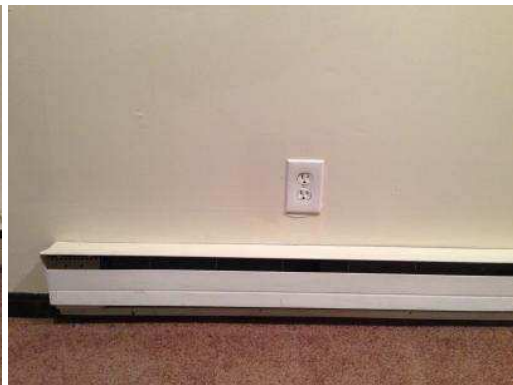
Acceptable Ceiling: Texture paint, Exposed framing
 Acceptable Walls: Paint
 Acceptable Floor: Carpet
 Acceptable Floor Drain: Surface drain
 Acceptable Doors: Hollow wood
 Acceptable Windows: Wood casement - Hard operation, Will not open
 Needs Repair Electrical: 110 VAC - Outlets should not be located above baseboard electric heaters. Remove outlet, terminate wires and install blank cover plate. Install cover plates on open work boxes.

9. Main Basement Electrical: 110 VAC - Outlets should not be located above baseboard electric heaters. Remove outlet, terminate wires and install blank cover plate. Install cover plates on open work boxes.

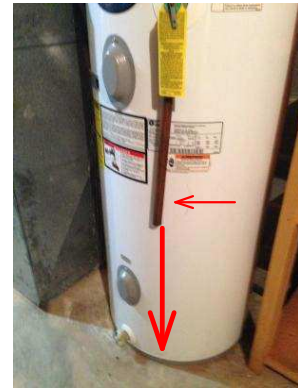
Acceptable Flue Pipe: Single wall
 Needs Repair TPRV and Drain Tube: Copper - **TPRV Drain tube opening should be located within six inches of the floor, Drain tube opening is not within six inches of the floor**

10. Basement Water Heater TPRV and Drain Tube: Copper - TPRV Drain tube opening should be located within six inches of the floor, Drain tube opening is not within six inches of the floor

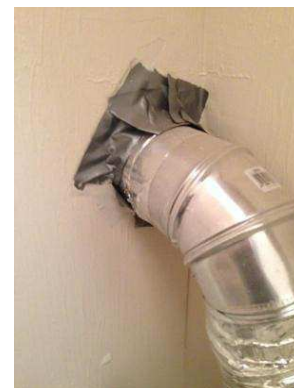
Acceptable Closet: None
 Acceptable Ceiling: Texture paint
 Acceptable Walls: Paint
 Acceptable Floor: Ceramic tile
 Acceptable Doors: Bi-fold
 Acceptable Windows: None
 Acceptable Electrical: 110 VAC, 220 VAC
 Acceptable Smoke Detector: None
 Acceptable HVAC Source: None
 Acceptable Laundry Tub Drain: PVC
 Acceptable Washer: None
 Acceptable Washer Hose Bib: Rotary
 Acceptable Washer and Dryer Electrical: 110-240 VAC
 Acceptable Dryer: None
 Needs Repair Dryer Vent: Metal flex - Possible loose connection of dryer vent flex line, evidenced by duct tape

11. 1st Floor Laundry Room/Area Dryer Vent: Metal flex - Possible loose connection of dryer vent flex line, evidenced by duct tape

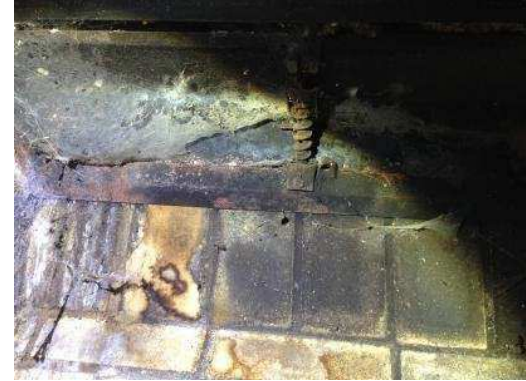
Needs Maintenance Freestanding Stove: Wood burning - **Recommend cleaning and inspection by a certified chimney professional, prior to use**

2. Living Room Fireplace Freestanding Stove: Wood burning - Recommend cleaning and inspection by a certified chimney professional, prior to use

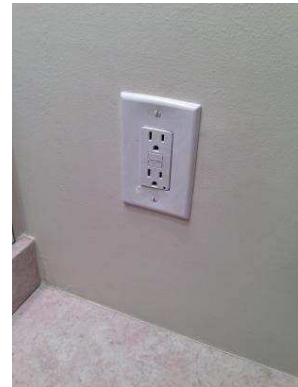
Acceptable	Closet: None
Acceptable	Ceiling: Texture paint
Acceptable	Walls: Paint
Acceptable	Floor: Ceramic tile
Acceptable	Doors: Hollow wood
Acceptable	Windows: Wood double hung
Defective	Electrical: 110 VAC GFCI - Faulty GFCI outlet-replace

1. Master Bathroom Electrical: 110 VAC GFCI - **Faulty GFCI outlet-replace**

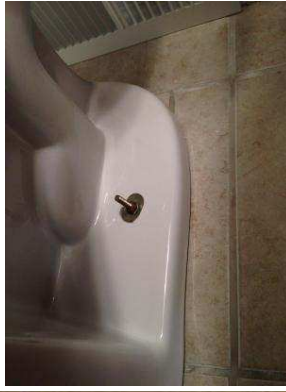
Toilets: 1 1/2 Gallon Tank - Toilet does not flush properly, Missing caps exposed flange bolts

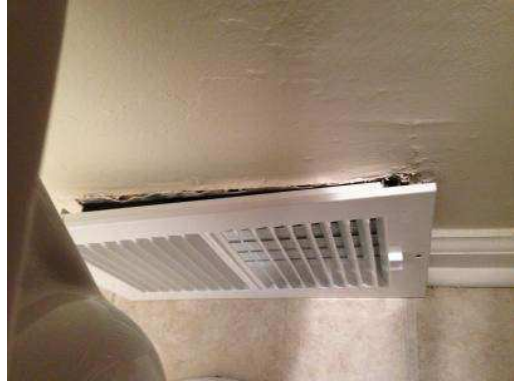
HVAC Source: Heating system register - Register cover not installed properly to opening

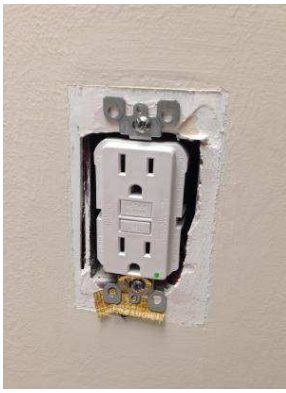
Electrical: 110 VAC GFCI - Missing outlet/switch cover plates

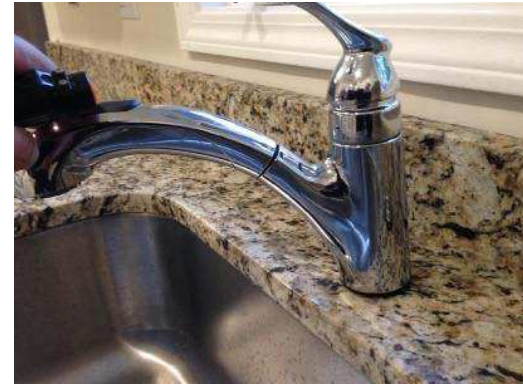
- Acceptable Cooking Appliances: Whirlpool, Westinghouse
- Acceptable Ventilator: Non-vented /non-ducted, re circulating exhaust fan
- Acceptable Disposal: In-Sinkerator
- Acceptable Dishwasher: Frigidaire
- Acceptable Microwave: General Electric
- Acceptable Sink: Stainless Steel
- Acceptable Electrical: 110 VAC GFCI
- Needs Repair Plumbing/Fixtures: Chrome - **The faucet is loose.**

15. 1st Floor Kitchen Plumbing/Fixtures: Chrome - **The faucet is loose.**

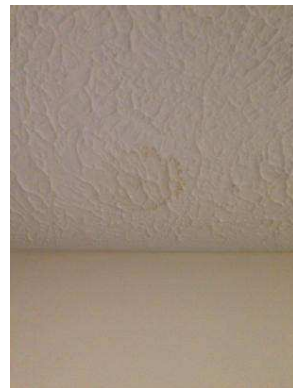
- Acceptable Counter Tops: Granite
- Acceptable Cabinets: Wood
- Acceptable Pantry: Small & Walk-in
- Needs Maintenance Ceiling: Texture paint - **Evidence of past or present water staining. Area is right below master bathroom shower. Recommend a qualified contractor or plumber to evaluate possible leaking.**

3. 1st Floor Kitchen Ceiling: Texture paint - Evidence of past or present water staining. Area is right below master bathroom shower. Recommend a qualified contractor or plumber to evaluate possible leaking.

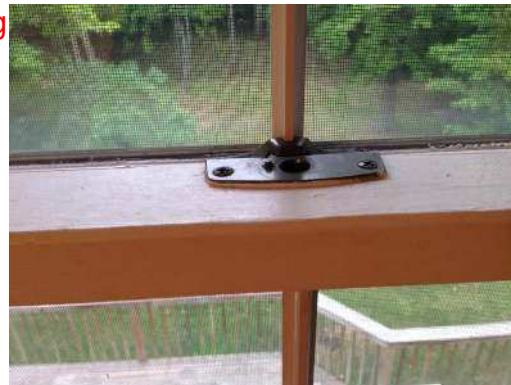
- Acceptable Closet: Small & Walk-in
- Acceptable Ceiling: Texture paint
- Acceptable Walls: Paint
- Acceptable Floor: Carpet
- Acceptable Doors: Hollow wood
- Needs Repair Windows: Wood double hung - **Repair faulty operating hardware**

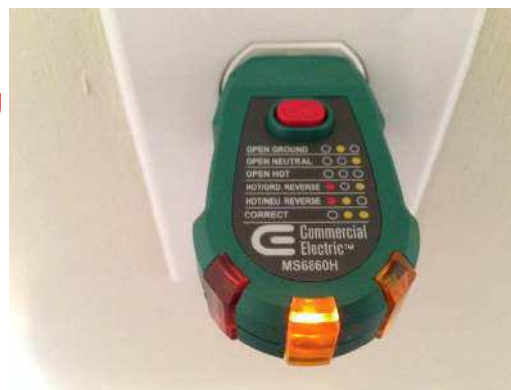
- Acceptable Closet: Small
- Acceptable Ceiling: Texture paint
- Acceptable Walls: Paint
- Acceptable Floor: Carpet
- Acceptable Doors: Hollow wood
- Acceptable Windows: Wood double hung
- Needs Repair Electrical: 110 VAC - **Open grounds noted at 3 prong outlets, Grounded receptacles should be replaced with non-grounded receptacles, where non grounded wiring is present.**

16. 2nd Floor Master Bedroom Windows: Wood double hung - **Repair faulty operating hardware**
17. Rear Bedroom Electrical: 110 VAC - **Open grounds noted at 3 prong outlets, Grounded receptacles should be replaced with non-grounded receptacles, where non grounded wiring is present.**
