# General Home Inspection

1234 Maple Rd.  
Loveland Hts., Ohio 44121

Prepared by: General Home Inspection

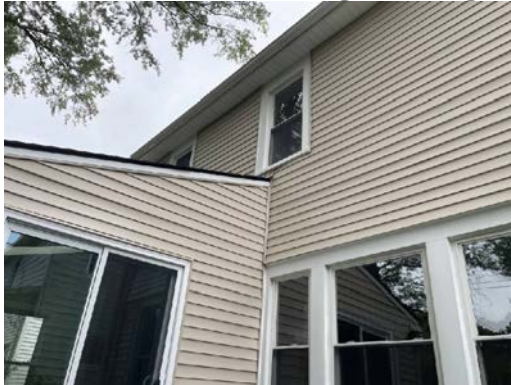
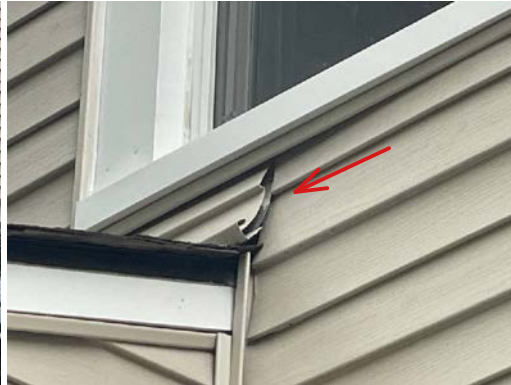
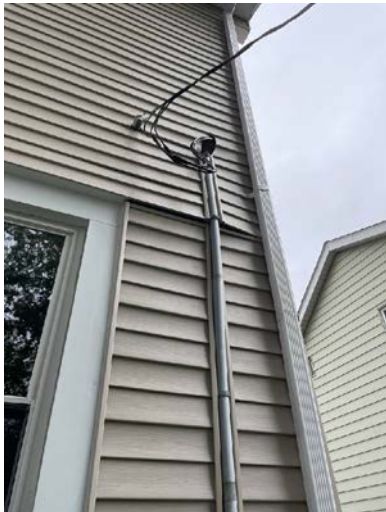
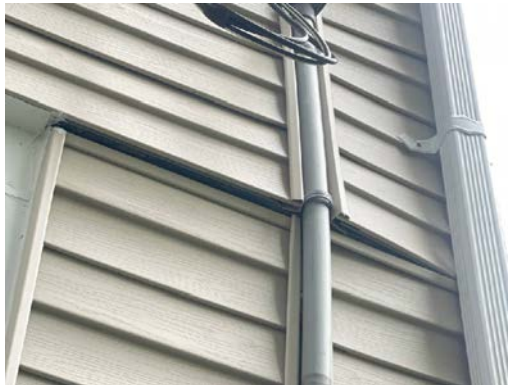
Type: Vinyl siding - Possibly improperly installed siding. Large gaps should be sealed or filled with color matching caulking.

1. East Exterior Surface Type: Vinyl siding - Possibly improperly installed siding. Large gaps should be sealed or filled with color matching caulking.
2. Entry Doors: Metal, Aluminum storms - Damaged self closing mechanism

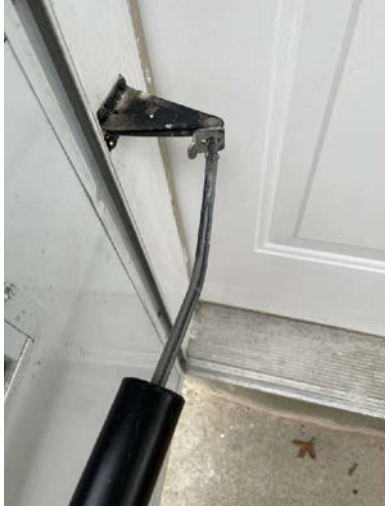
Soffits: Vinyl  
Entry Doors: Metal, Aluminum storms - Damaged self closing mechanism

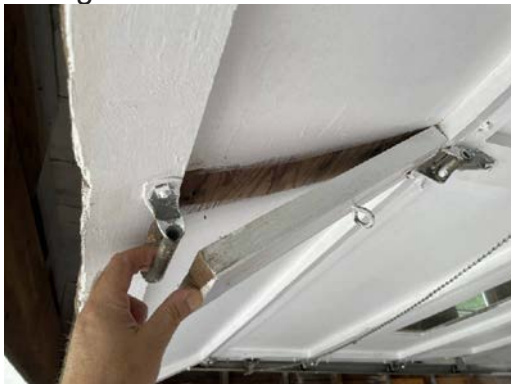
Type of Structure: Detached Car Spaces: 1  
Needs Repair Garage Doors: Wood - Loose wood on doors

3. Detached Garage Garage Doors: Wood - Loose wood on doors
4. Detached Garage Walls: Exposed framing - **Some missing wall studs on rear wall, recommend replacing, Rear garage wall was not repaired with proper building techniques. Studs need to extend fully from the top plate to the bottom plate. Bottom plate is missing Wall repairs needed**

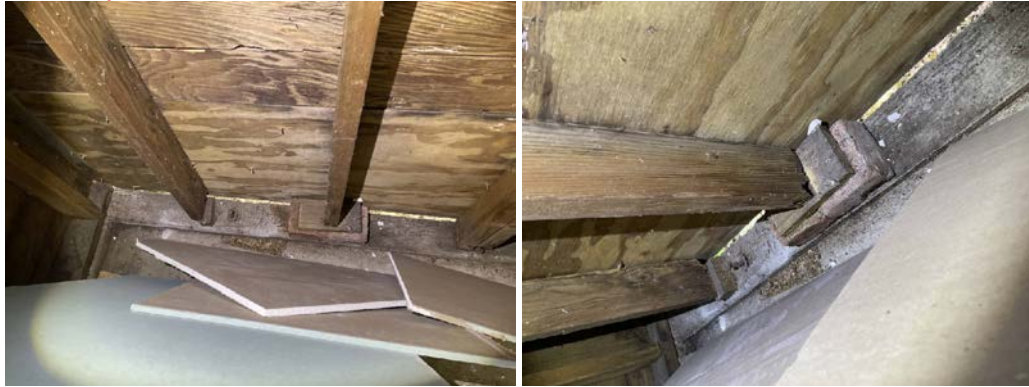
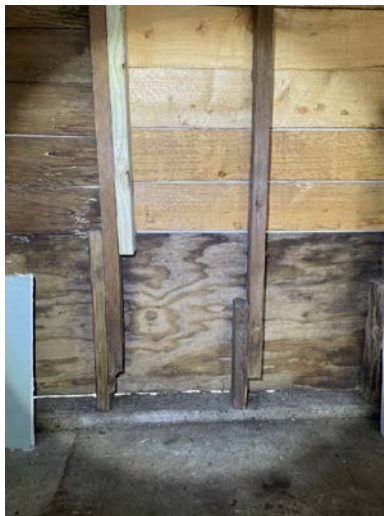
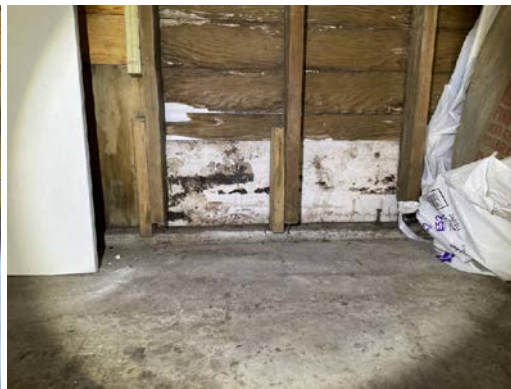
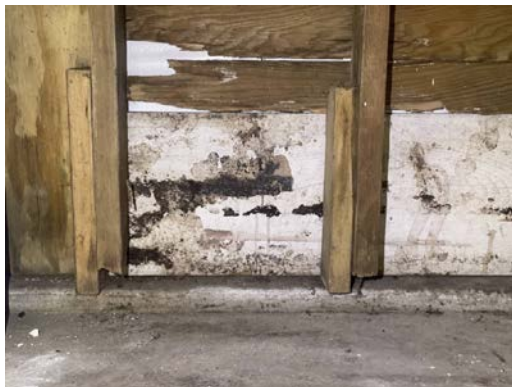
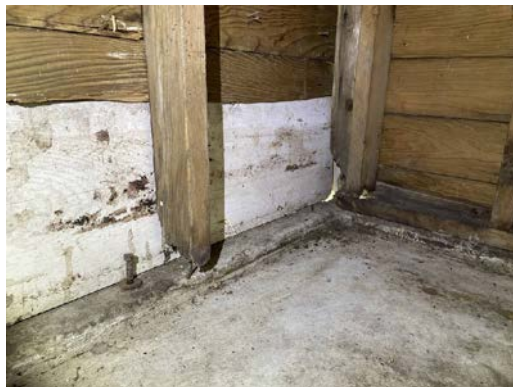
Needs Repair, Defective Walls: Exposed framing - **Some missing wall studs on rear wall, recommend replacing, Rear garage wall was not repaired with proper building techniques. Studs need to extend fully from the top plate to the bottom plate. Bottom plate is missing. Wall repairs needed**

1. Detached Garage Walls: Exposed framing - Some missing wall studs on rear wall, recommend replacing, Rear garage wall was not repaired with proper building techniques. Studs need to extend fully from the top plate to the bottom plate. Bottom plate is missing  
Wall repairs needed

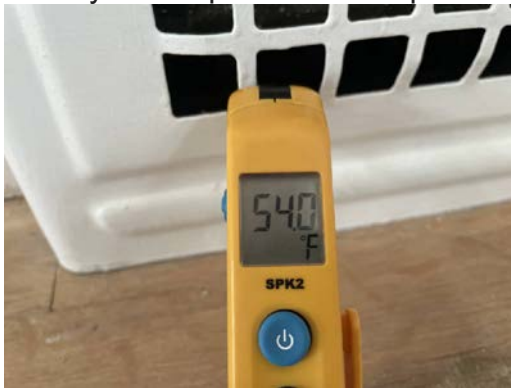
Acceptable A/C System Operation: Adequate - A temperature of 60 degrees or below is optimal

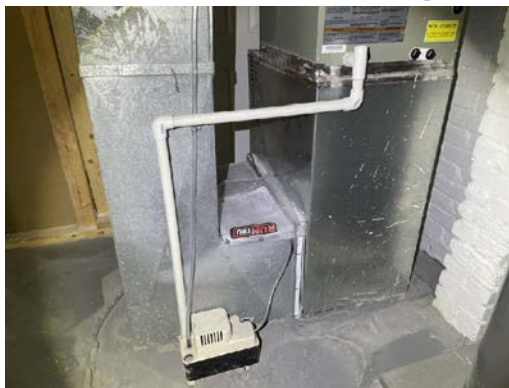
Needs Repair, Defective Condensate Removal: PVC, Electric pump - A simple inquiry on goggle shows that this drain system for the condensation line is not correct. Recommend a licensed HVAC contractor to evaluate and repair as required

5. Main AC System Condensate Removal: PVC, Electric pump - A simple inquiry on goggle shows that this drain system for the condensation line is not correct. Recommend a licensed HVAC contractor to evaluate and repair as required

2. Main AC System Condensate Removal: PVC, Electric pump - A simple inquiry on goggle shows that this drain system for the condensation line is not correct.  
Recommend a licensed HVAC contractor to evaluate and repair as required

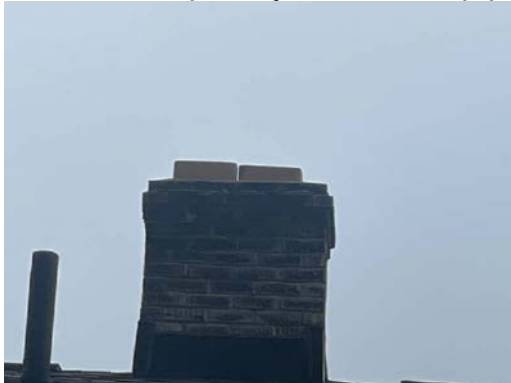
Needs Repair Flue/Flue Cap: Clay, No Flue cap present - Recommend adding rain/snow and bird cap

6. Main Roof Surface Flue/Flue Cap: Clay, No Flue cap present - Recommend adding rain/snow and bird cap

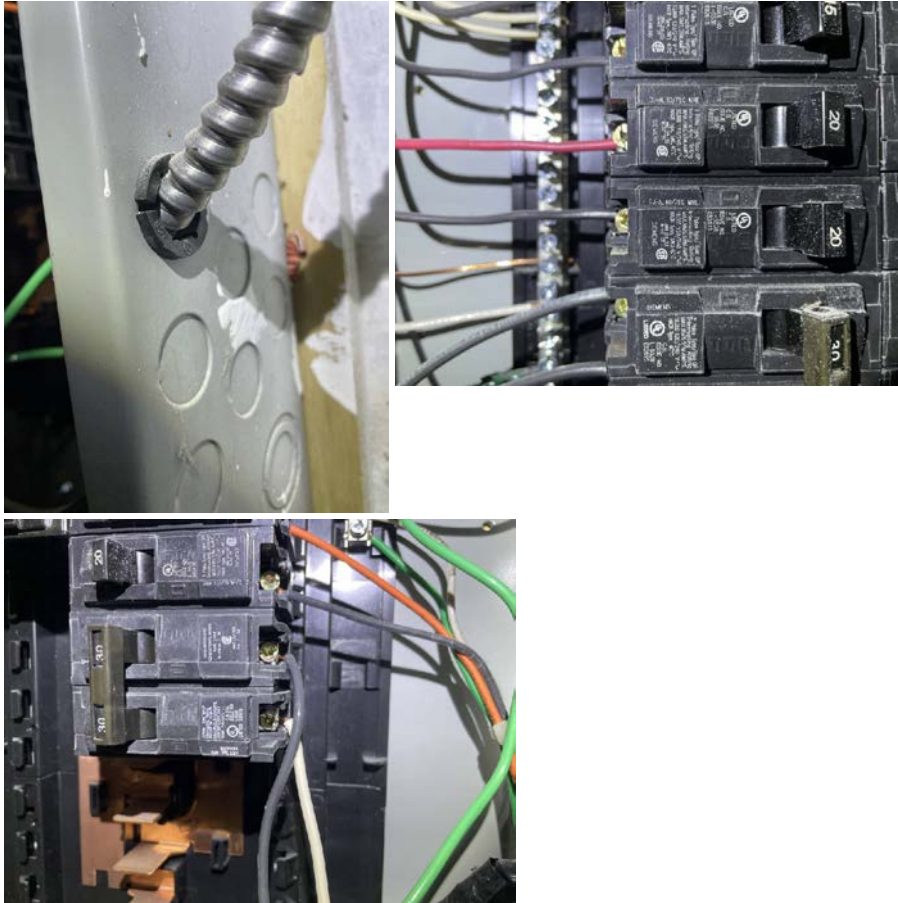
Disconnecting means. Where two or more branch circuits supply devices (or equipment) on the same yoke, you must provide a means to disconnect simultaneously all ungrounded conductors that supply those devices or equipment. [210.7(B)] Individual single-pole circuit breakers with handle ties identified for the purpose can be used for this application [240.20(B)(1)]. So can a breaker with a common internal trip. This rule prevents people from working on energized circuits they thought were disconnected.

220 circuit wires must be clearly marked when the white neutral wire is used as a hot line. It should be color coded red

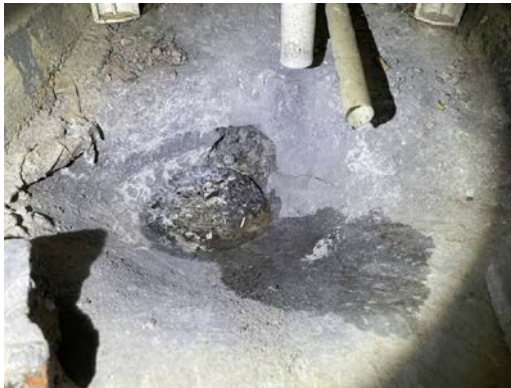
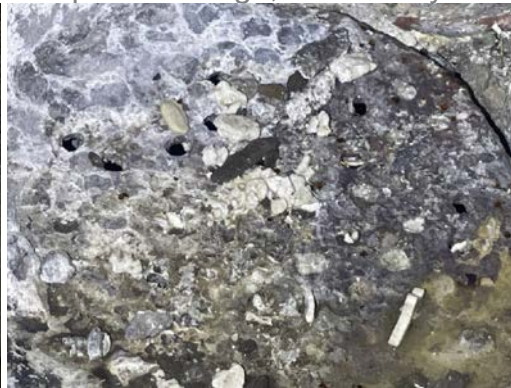
Floor Drain: Surface drain - Evidence of drainage, Blocked by debris

8. Main Basement Floor Drain: Surface drain - Evidence of poor drainage, Blocked by debris
9. Main Basement Electrical: 110 VAC - **Install missing junction boxes and cover plates at open splice connections**

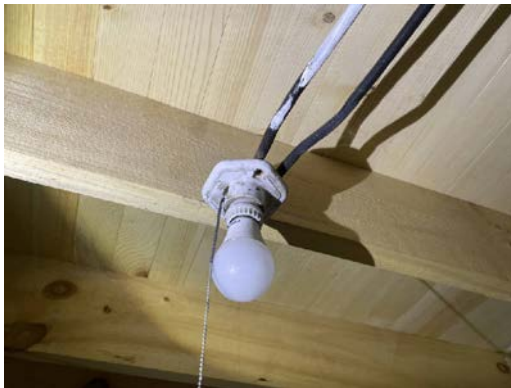
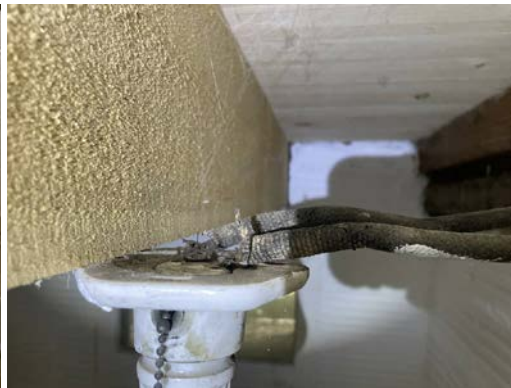
Electrical: 110 VAC - **Install missing junction boxes and cover plates at open splice connections**

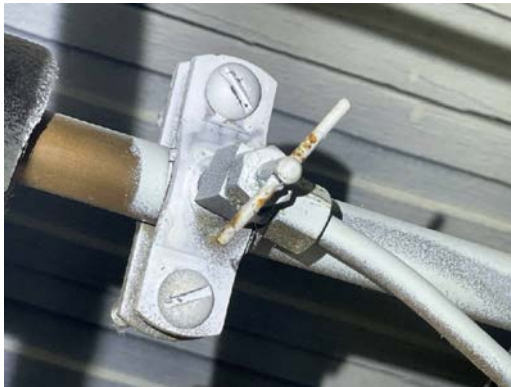
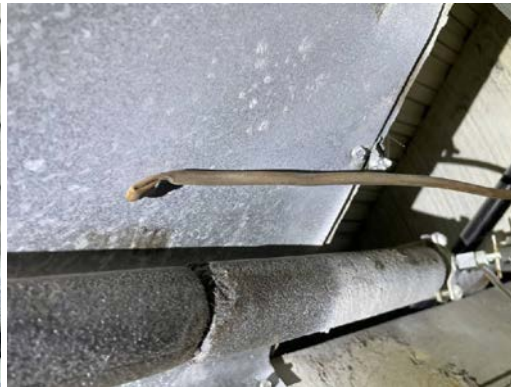
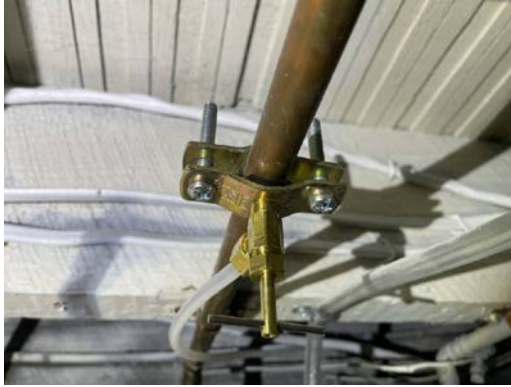
Service Line: Copper  
Main Water Shutoff: Basement, Front of house  
Water Lines: Copper - Old not utilized saddle valve should be removed, Saddle valve in supply pipe, these are prone to leaking and should be changed to the proper fitting

10. Water Lines: Copper - Old not utilized saddle valve should be removed, Saddle valve in supply pipe, these are prone to leaking and should be changed to the proper fitting
11. Drain Pipes: PVC, Cast iron - **The Fernco neoprene sleeves are not permitted aboveground. The reason is they do not hold the pipes firmly enough to prevent movement. A banded coupler has a clamp that covers the entire sleeve thus making a firm joint. This installation would never pass an inspection by the city plumbing inspector**

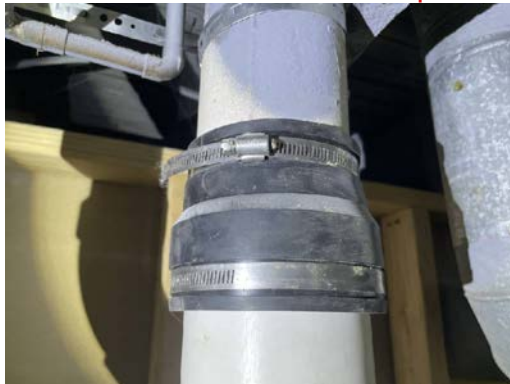
Needs Repair, Defective Drain Pipes: PVC, Cast iron - The Fernco neoprene sleeves are not permitted aboveground. The reason is they do not hold the pipes firmly enough to prevent movement. A banded coupler has a clamp that covers the entire sleeve thus making a firm joint.

This installation would never pass an inspection by the city plumbing inspector

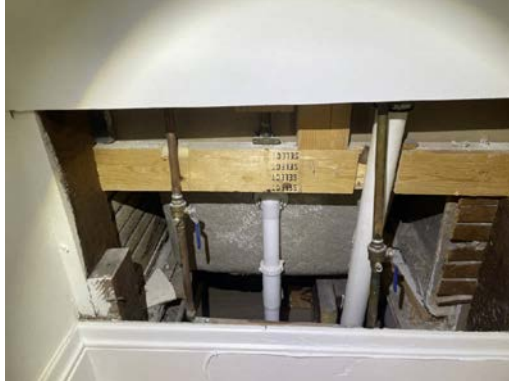
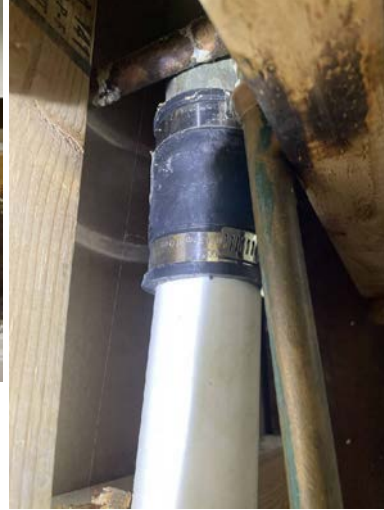
Needs Repair, Defective Vent Pipes: PVC, Galvanized - The Fernco neoprene sleeves are not permitted aboveground. The reason is they do not hold the pipes firmly enough to prevent movement. A banded coupler has a clamp that covers the entire sleeve thus making a firm joint.

This installation would never pass an inspection by the city plumbing inspector

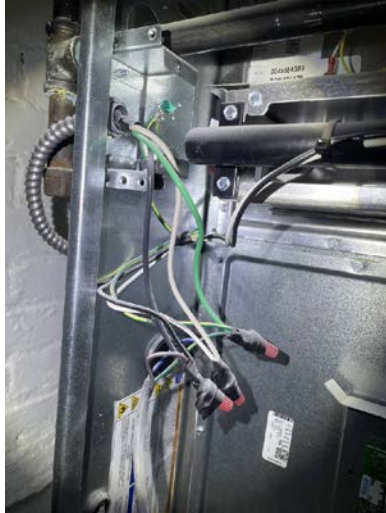
Needs Repair, Defective Electrical: 110 VAC - Exposed wiring should be terminated with wire nuts and enclosed in work box

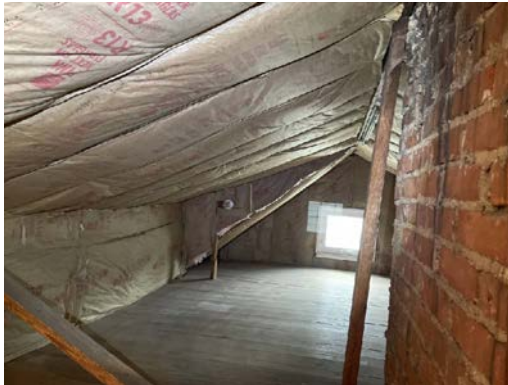
Not Inspected	Unable to Inspect: 75% - Insulation, Limited access
Not Inspected	Roof Framing: Covered Ceiling
Not Inspected	Sheathing: Unable to determine
Acceptable	Ventilation: Gable vent, Windows
Needs Repair	Insulation: Fiberglass, Batts - Exposed kraft insulation vapor barrier, protect per manufacturer's recommendations

Caution This Facing will burn. Do not leave exposed Facing must be installed in substantial contact with an approved ceiling, floor or wall material. Keep open flame and other heat sources away from facing.

Acceptable	Insulation Depth: 3", 6"
Acceptable, Needs Repair, Defective Vapor Barrier:	Paper - Exposed kraft insulation vapor barrier, protect per manufacturer's recommendations
Acceptable	Electrical: 110 VAC
Acceptable	Moisture Penetration: None observed at time of inspection

14. Main Attic Insulation: Fiberglass, Batts - Exposed kraft insulation vapor barrier, protect per manufacturer's recommendations  
15. Main Attic Vapor Barrier: Paper - Exposed kraft insulation vapor barrier, protect per manufacturer's recommendations

6. Main Attic Vapor Barrier: Paper - Exposed kraft insulation vapor barrier, protect per manufacturer's recommendations

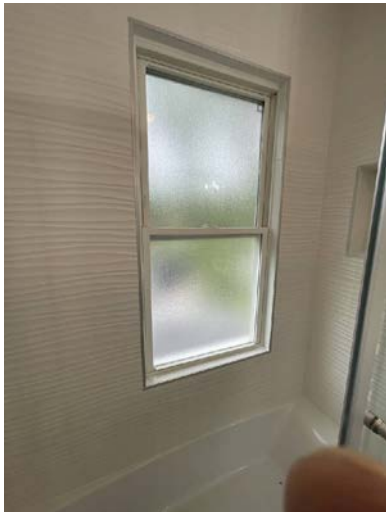
Acceptable	Ceiling: Paint
Acceptable	Walls: Paint
Acceptable	Floor: Ceramic tile
Acceptable	Doors: Solid wood
Needs Repair	Windows: Vinyl double hung - Recommend a vinyl curtain so water will not get inside window or behind wall.

16. 2nd Floor Bathroom Windows: Vinyl double hung - Recommend a vinyl curtain so water will not get inside window or behind wall.  
17. 2nd Floor Bathroom Tub/Surround: Fiberglass tub and ceramic tile surround - Recommend caulking around tub spigot  
18. Basement Bathroom Faucets/Traps: Delta fixtures with a PVC trap - Basement sink drain doesn't appear to be professionally installed.  
This installation may not pass an inspection by the city plumbing inspector

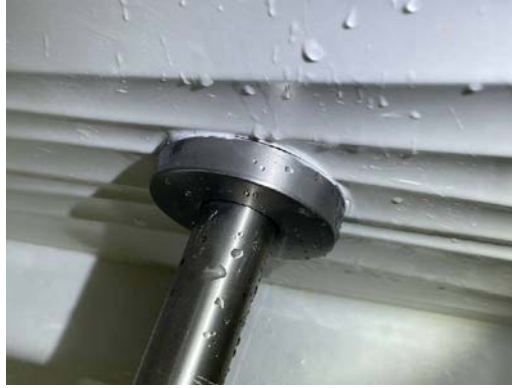
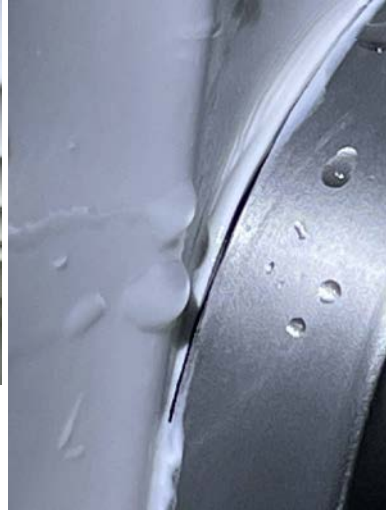
Acceptable, Needs Repair Tub/Surround: Fiberglass tub and ceramic tile surround - Recommend caulking around tub spigot

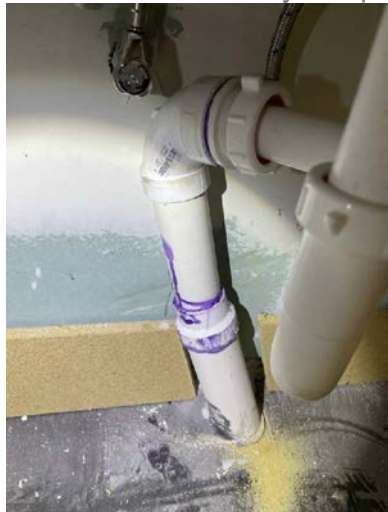
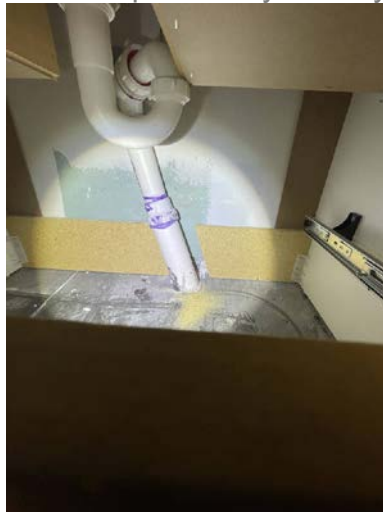
Ceiling: Paint  
Walls: Paint  
Floor: Ceramic tile  
Doors: Hollow wood  
Windows: Glass block  
Electrical: 110 VAC GFCI  
Counter/Cabinet: Solid Surface, Composite and wood  
Sink/Basin: One piece sink/counter top  
Faucets/Traps: Delta fixtures with a PVC trap - Basement sink drain doesn't appear to be professionally installed.

This installation may not pass an inspection by the city plumbing inspector

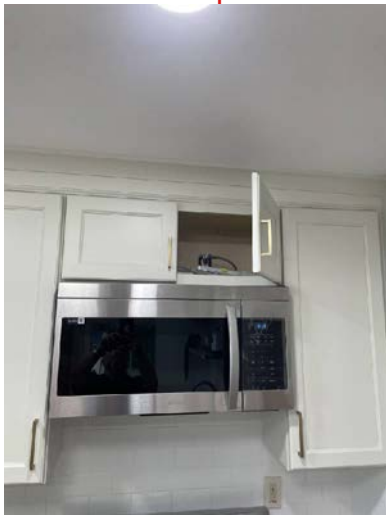
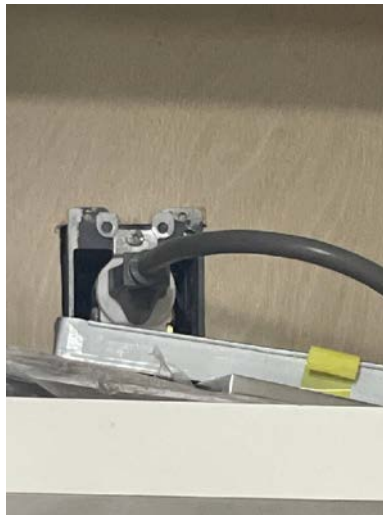
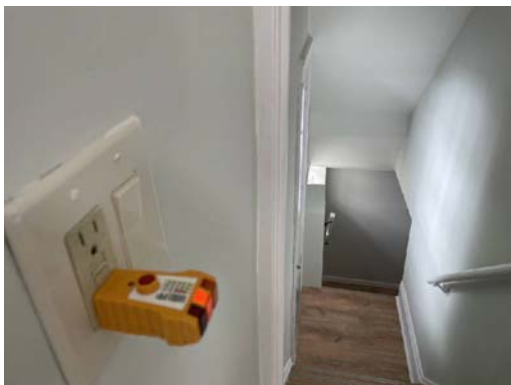
Acceptable Cooking Appliances: Gas, Samsung  
 Acceptable Disposal: Wastemaid  
 Acceptable Dishwasher: Samsung  
 Acceptable Refrigerator: Samsung  
 Acceptable Microwave: Samsung  
 Acceptable Sink: One piece farm sink  
 Needs Repair Electrical: 110 VAC, 110 VAC GFCI - Missing outlet cover plate, Open or missing ground noted at GFCI protected outlet. Should be labeled as non-grounded GFCI receptacle.

19. 1st Floor Kitchen Electrical: 110 VAC, 110 VAC GFCI - Missing outlet cover plate, Open or missing ground noted at GFCI protected outlet. Should be labeled as non-grounded GFCI receptacle.  
20. 1st Floor Kitchen HVAC Source: None - No heat duct, When the winter design temp. per Table R301.2(1) is below 60 deg., Section R303.8 requires every dwelling unit to have heating facilities capable of maintaining a minimum room temperatures of 68 deg in all habitable rooms. In other words, it requires 68 deg in all habitable rooms, not that the heating facilities themselves be located in each room.

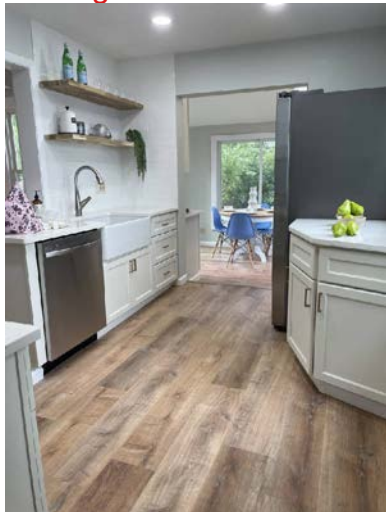
Acceptable	Plumbing/Fixtures: Chrome, PVC
Acceptable	Counter Tops: Solid surface
Acceptable	Cabinets: Laminate and composite materials
Acceptable	Ceiling: Paint
Acceptable	Walls: Paint, Paint and tile
Acceptable	Floor: Vinyl floor covering
Acceptable	Windows: Vinyl double hung
Needs Repair, Defective	HVAC Source: None - No heat duct, When the winter design temp. per Table R301.2(1) is below 60 deg., Section R303.8 requires every dwelling unit to have heating facilities capable of maintaining a minimum room temperatures of 68 deg in all habitable rooms. In other words, it requires 68 deg in all habitable rooms, not that the heating facilities themselves be located in each room.

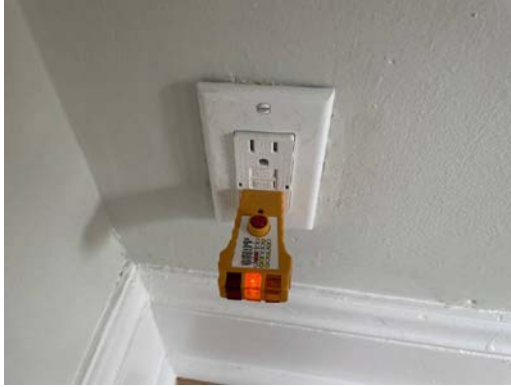
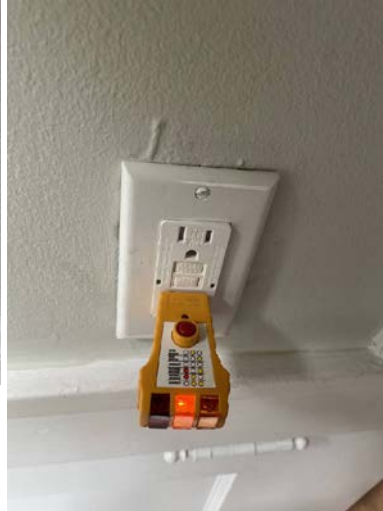
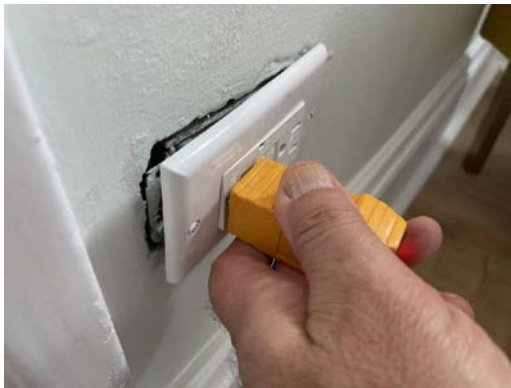
Electrical: 110 VAC, 110 VAC GFCI - Open or missing ground noted at GFCI protected outlet. Should be labeled as non-grounded GFCI receptacle. Loose outlet should be resecured

21. 2nd floor Bedroom Electrical: 110 VAC, 110 VAC GFCI - Open or missing ground noted at GFCI protected outlet. Should be labeled as non-grounded GFCI receptacle. Loose outlet should be resecured

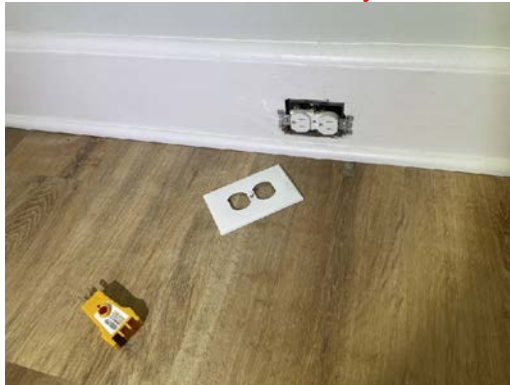
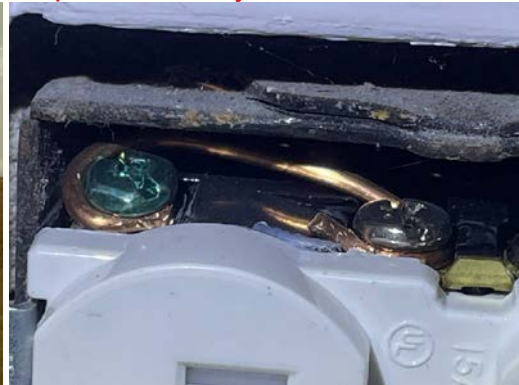
Needs Repair, Defective Electrical: 110 VAC - Possibly improperly wired outlets.

The neutral wire should never have excess bare wiring exposed inside of a metal box.  
The ground wire is barely under the ground screw.

These outlets were clearly not installed professionally.

22. Living Room, Dining Room Living Space Electrical: 110 VAC - Possibly improperly wired outlets. The neutral wire should never have excess bare wiring exposed inside of a metal box. The ground wire is barely under the ground screw.

8. Living Room, Dining Room Living Space Electrical: 110 VAC - Possibly improperly wired outlets. The neutral wire should never have excess bare wiring exposed inside of a metal box. The ground wire is barely under the ground screw.
